## SEAWALL AND BULKHEAD REPAIR AND PRESERVATION

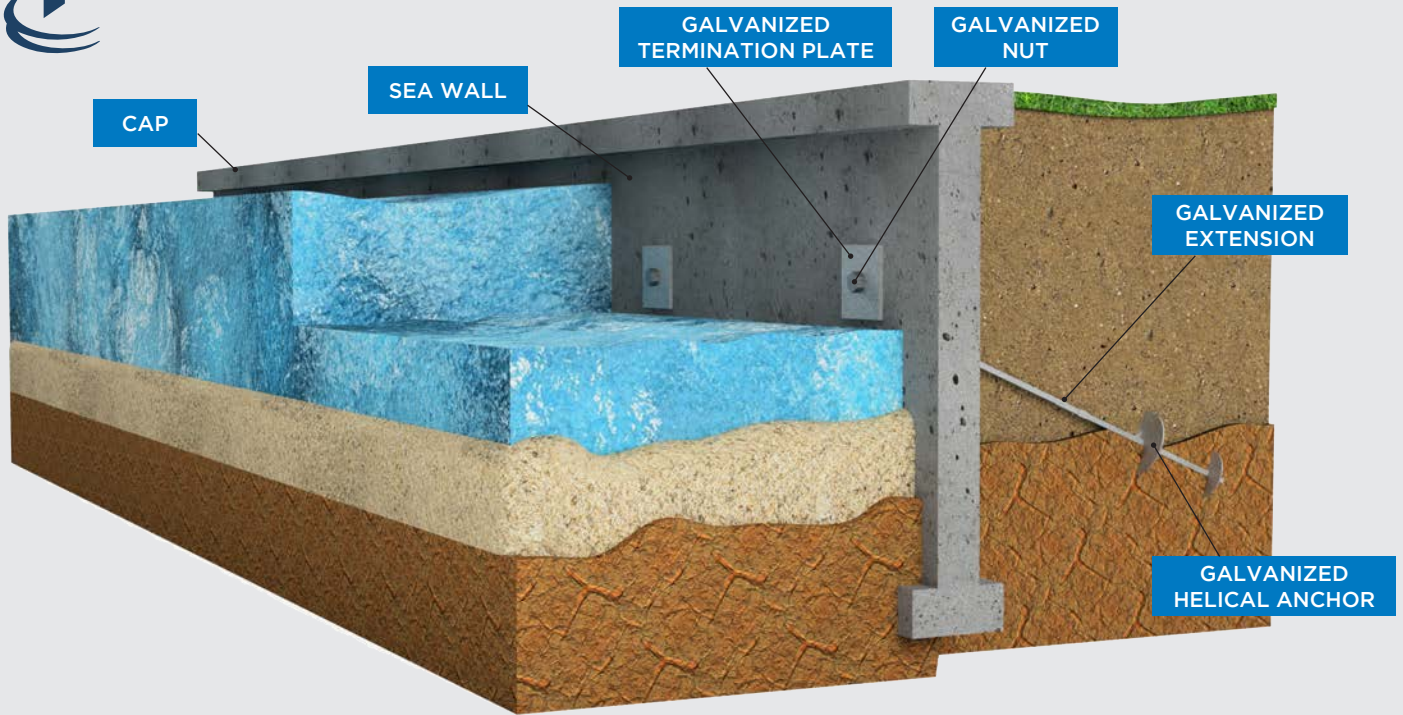
When a seawall or bulkhead presents depression in the soil behind the wall, cracks in the concrete slab, rust stains on the surface, or movement, deterioration is occurring and failure of the wall is likely. Should the wall fail, catastrophic damage can occur. This deterioration is caused by unstable soil behind the wall, which is a result of erosion, poor compaction, the freeze/thaw cycle, decomposition, or excess water saturation.

Failing seawalls and bulkheads can be repaired with CHANCE Helical Tieback Anchors.

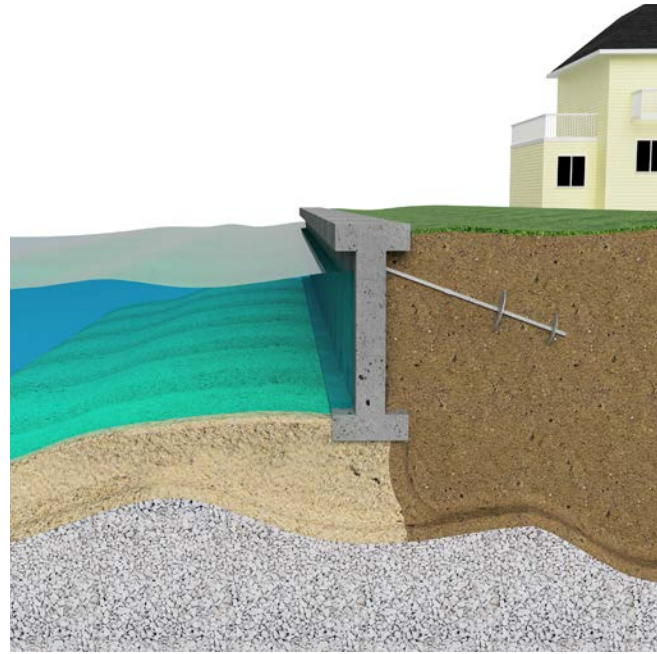
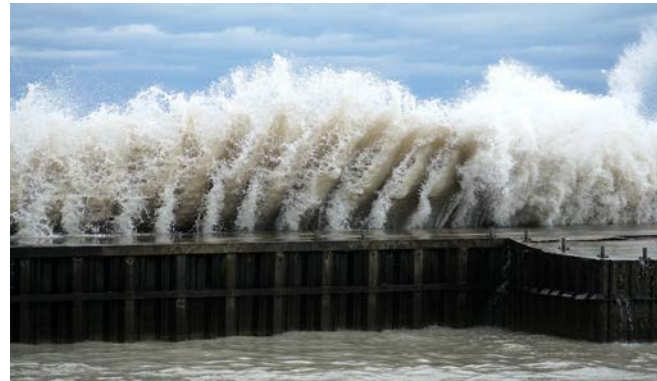
The CHANCE helical tieback anchor is a superior solution compared to a conventional deadmen method because it reduces the need for excavation, is installed remarkably quickly, and creates tension immediately.

Our anchors are classified as soil anchors and the loads are developed based on the capacity of the soil behind the wall. The holding capacity is proportional to the installation torque of each anchor. The length and bearing area can be adjusted in the field to meet the specified load requirements for the project.
